## Ygnacio Valley Elementary School

### OVERVIEW

### Property Condition

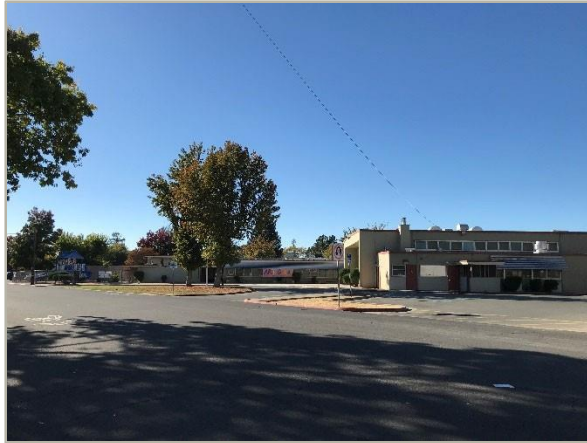
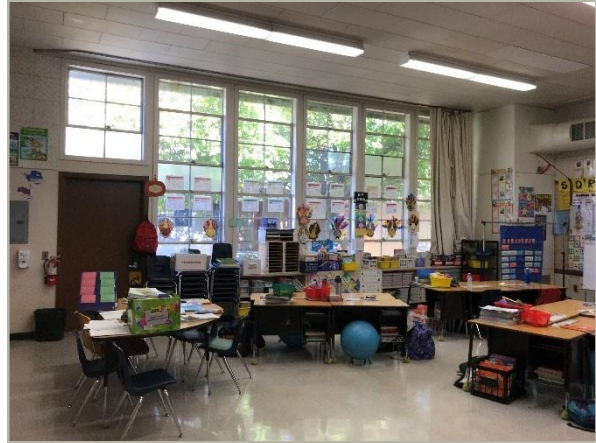
### Building Type 1 Information

| Building Type 1 Information | | |
|---|---|---|
| <b>Key Issues &amp; Findings</b> | Buildings lacks fire suppression. | |
