## Monte Gardens Elementary School

### OVERVIEW

#### **Property Executive Summary**

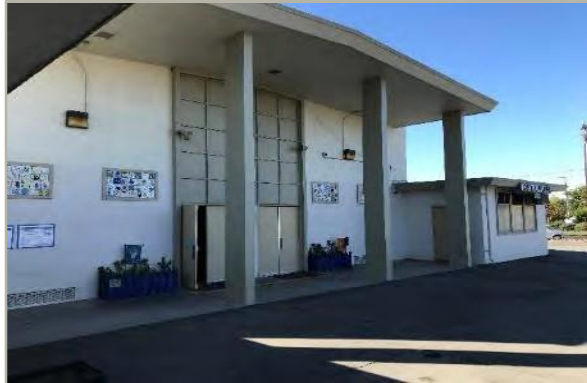
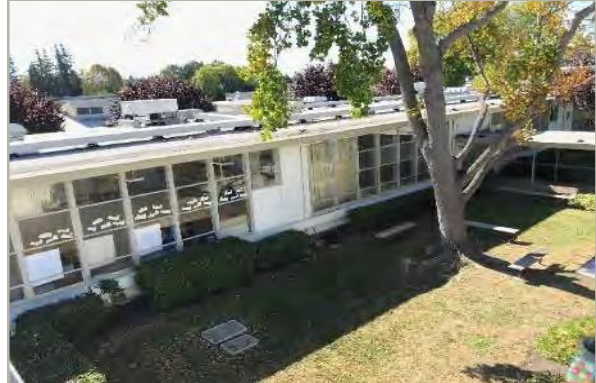
| Building Type 1 Information | | |
|---|---|---|
| <b>Key Issues &amp; Findings</b> | Antiquated HVAC components and infrastructure in M-U, building lacks fire suppression, possible ACM flooring | |

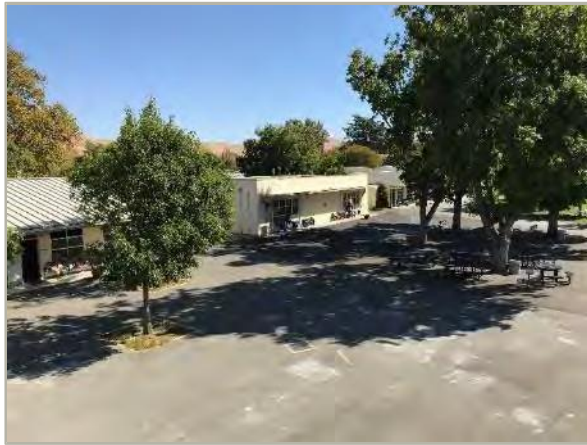
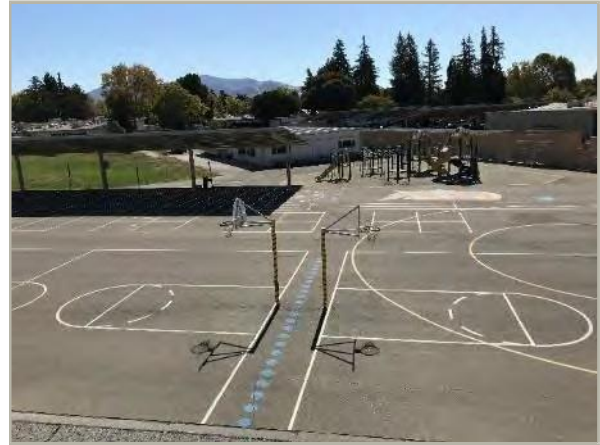
| Site Information | | |
|---|---|---|
| <b>Key Issues &amp; Findings</b> | Minor alligator cracking in parking lots and sidewalks, major cracks and trip hazards in pedestrian pavement north of A Wing. | |
