## Strandwood Elementary School

#### **Property Executive Summary**

### Summary of Findings

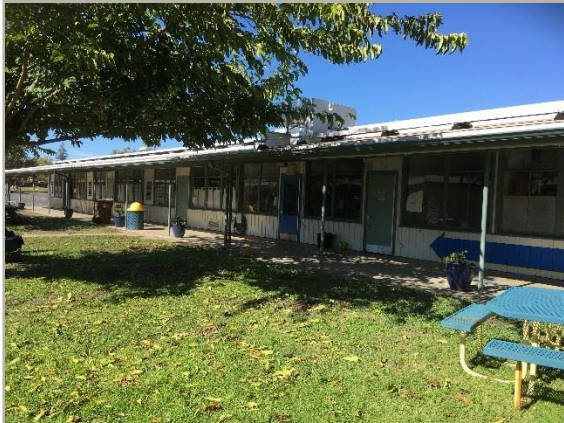
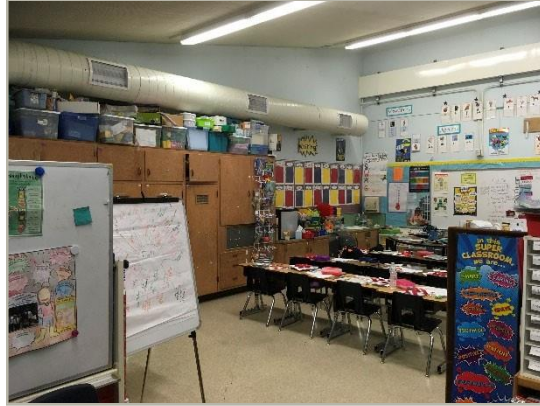
### Building Type 1 Information

| Building Type 1 Information | | |
|---|---|---|
| <b>Key Issues &amp; Findings</b> | Buildings lack fire suppression, sink drains in restrooms are not wrapped per ADA, some floor tile is 9"x9" which may contain asbestos, gutters have seam leaks, ceiling tile is in poor condition, wooden lap board siding has several areas of warping and unprotected material | |

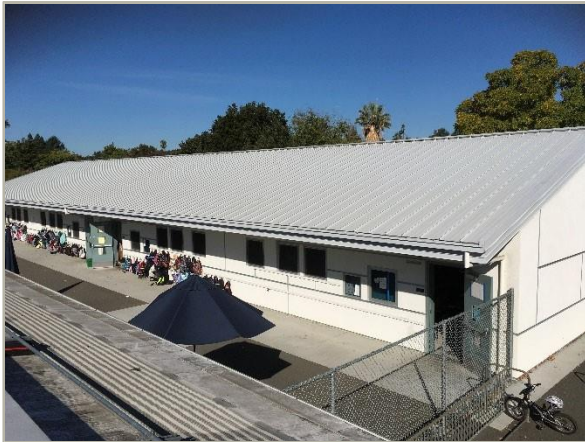
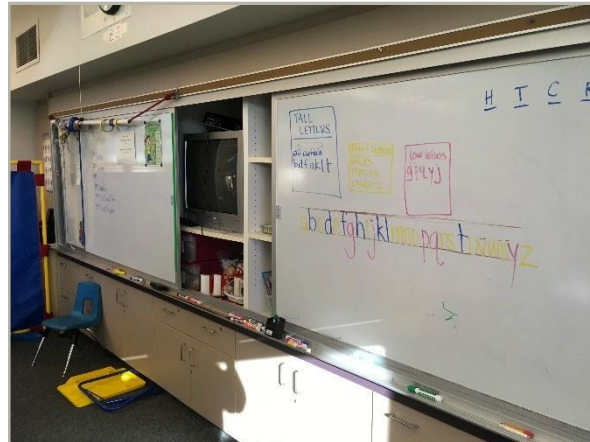
### Building Type 2 Information

| Building Type 2 Information | | |
|---|---|---|
| <b>Key Issues &amp; Findings</b> | Buildings lack fire suppression | |

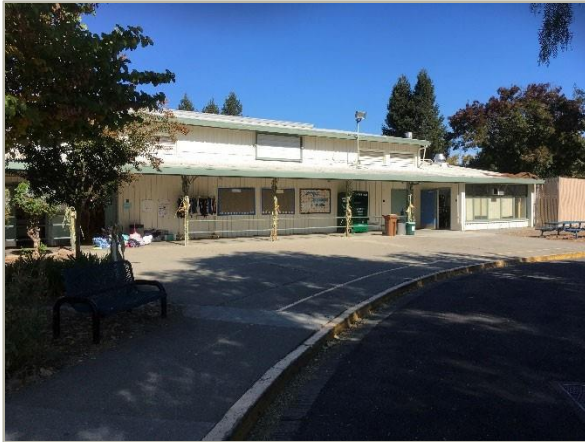
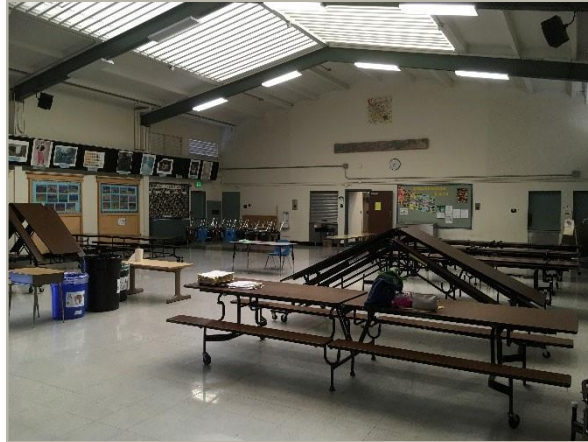
### M-U Building Information

| M-U Building Information | | |
|---|---|---|
| <b>Key Issues &amp; Findings</b> | Building lacks fire suppression, kitchen hood lacks fire suppression, boiler has exceeded its EUL | |

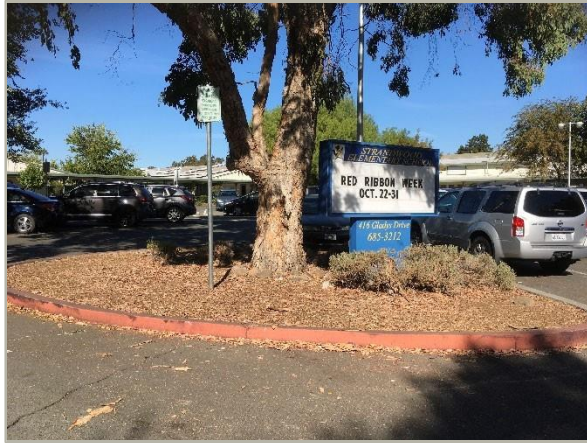
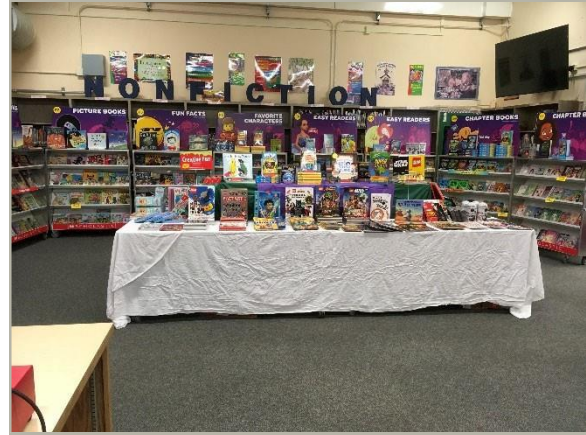
### Site Summary Information

| Site Information | | |
|---|---|---|
| <b>Key Issues &amp; Findings</b> | Plant growth into south side chain link fencing | |
