## Ayers Elementary School

### OVERVIEW

#### **Property Executive Summary**

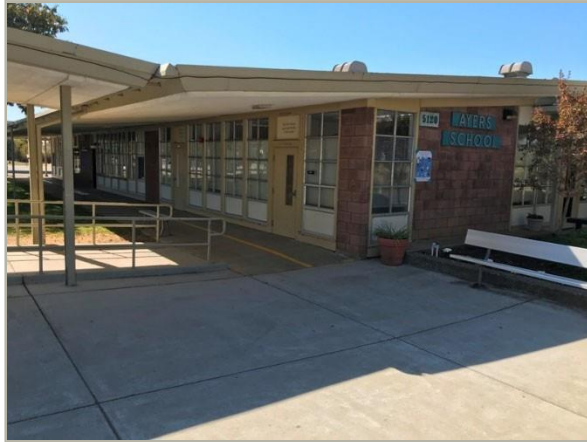
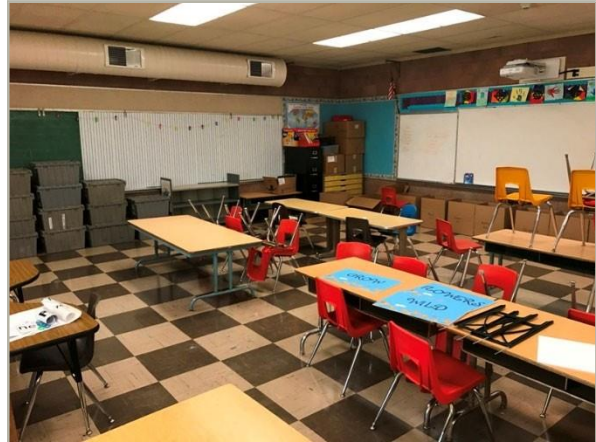
### Building A 1-2, B Wing, C Wing, D Wing, E Wing Information

| Building A 1-2, B Wing, C Wing, D Wing, E Wing Information | | |
|---|---|---|
| <b>Key Issues &amp; Findings</b> | Lacks fire sprinklers | |

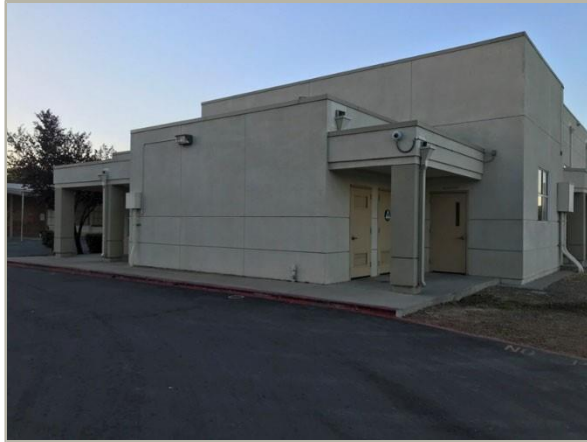
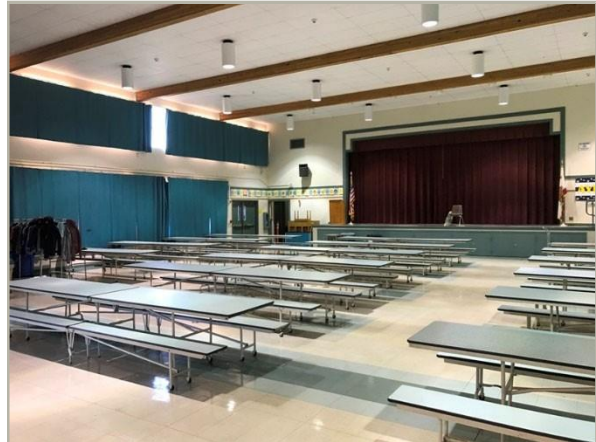
### Building M-U Information

| Building M-U Information | | |
|---|---|---|
| <b>Key Issues &amp; Findings</b> | Only partial fire sprinkler protection | |

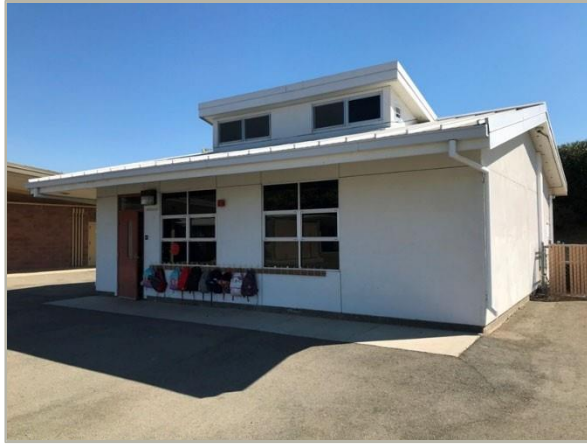
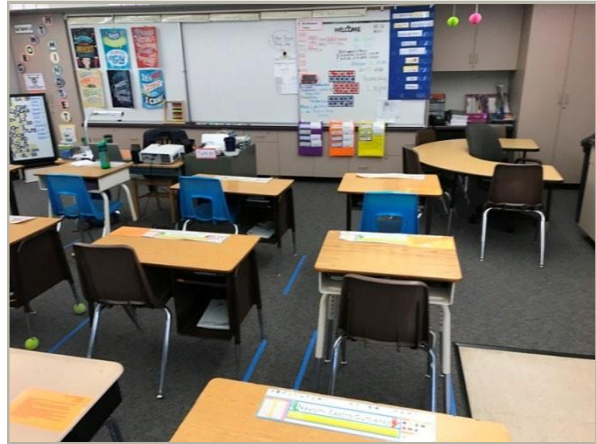
### Building B -6, Daycare Information

| Building B-6, Daycare Information | | |
|---|---|---|
| <b>Key Issues &amp; Findings</b> | No fire sprinklers | |
