## EXISTING SITE CONDITIONS

### FLORA VISTA ELEMENTARY

Encinitas Union School District  
Facilities Plan Update

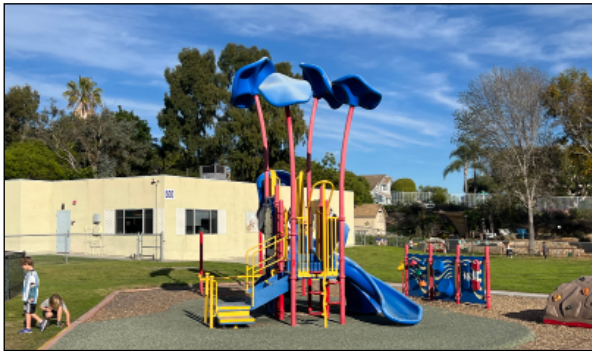
Kinder Play Apparatus

- The main play equipment north of shade structure was replaced in the 2018-2019 school year and is in good condition.
- Pre-K play equipment was replaced in Summer 2020.
- Replace fiber chips in fall zone with rubberized surfacing.
- Ball walls are in good condition.
- Swings are in good condition, replace fiber chips with rubber.
- Basketball goals and posts are in good condition.
- Baseball infield areas should be removed or re-worked. Potential replacement of backstops.

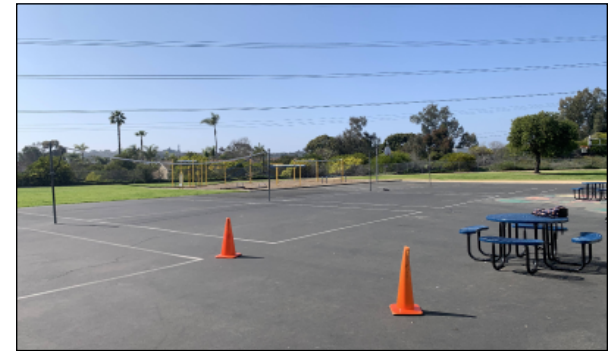
- Hardcourts are in fair condition with some areas cracking. Grind, re-seal and re-stripe.

- Verify potential cross slope issues (>2%).
- Worn striping in some areas.
