# EXISTING SITE CONDITIONS

## FARM LAB DREAMS CAMPUS

Encinitas Union School District  
Facilities Plan Update

LPA

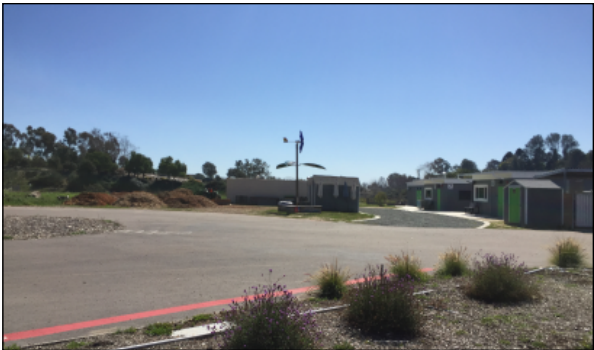
Central Access Road

- Existing paving at access road and roundabout is in good condition.
- Verify potential cross slope issues (>2%) at path of travel in future work.

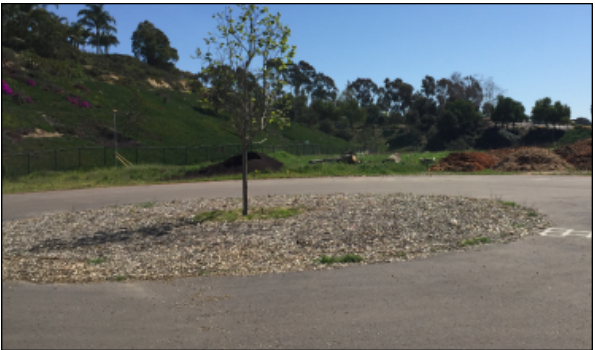
Roundabout

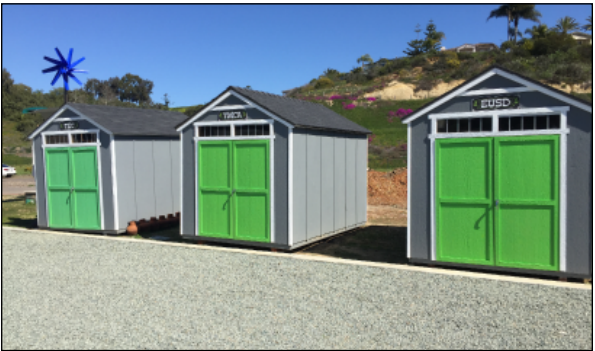
Storage Sheds

- Address storage issues by providing a garage building with slab-on-grade construction would help alleviate storage issues and provide storage for site tractor and vehicles.

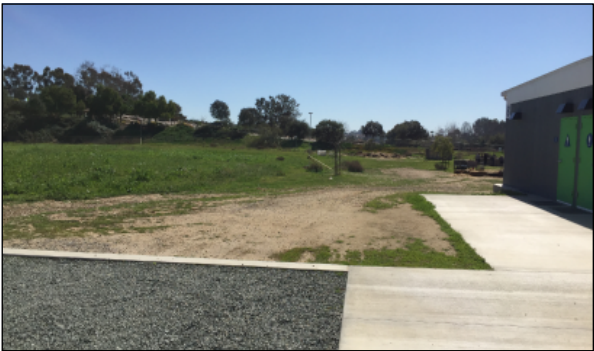
Hardscape adjacent to Restroom Portable 8

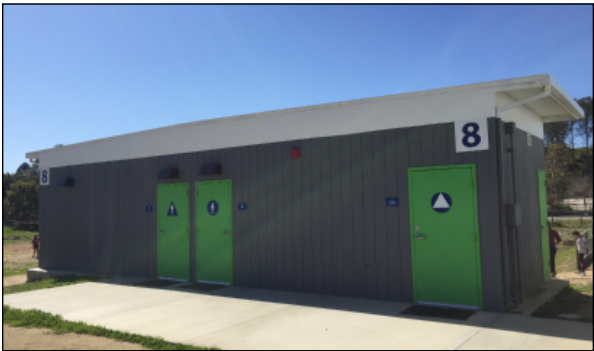
Restroom Portable 8

- Restrooms have had previous ADA upgrades, but it was noted that the original restroom portable to the west of the Carrot classroom is dated and should be updated.
- Verify plumbing fixture count in future work and consider adding an additional adult visitor restroom.
- Classroom sinks and casework have had ADA upgrades.
- There are (2) drinking fountains on site that is the accessible 'hi-low' type, with a filtered bottle filling station.
- Room signage is current and in good condition.
- Path of travel compliance needs to be evaluated in future work.
- A more detailed assessment and survey will

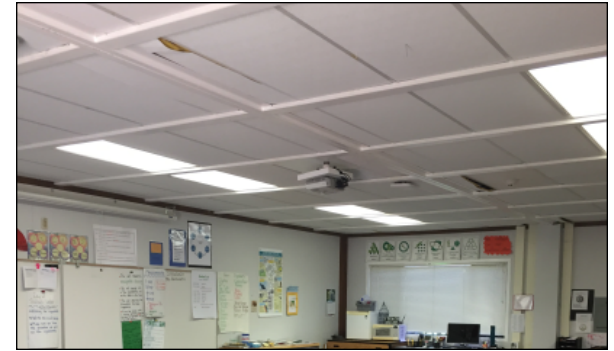
Classroom ACT Ceiling - Portables 1-4

- Interior painting was completed in the 2018-2019 school year and is in good condition.
- Flooring was updated in the 2018-2019 school year and is in good condition. Note all classrooms have vinyl flooring.
- Classrooms do not have built-in casework, to provide adequate space for mobile storage units. Noted that additional mobile storage is needed.
- Classroom ceilings are ACT-type and are in good condition. Note the (2) Dill and Rosemary classrooms have no finish ceiling and are open to the structure above.

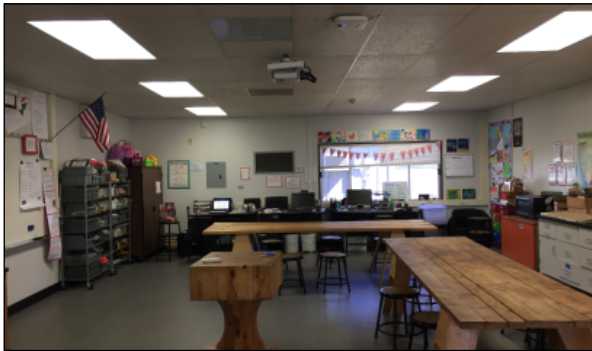
Classroom Interior - Avocado 4

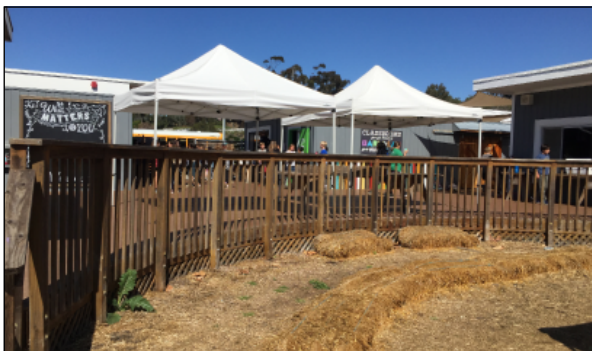
Central Deck/Hay Bales at Classrooms 1-4

- There is an existing Welcome Dome and a Road Trip Mobile Classroom at the north half of the site (Ecology Center).
- There is an existing deck between Classroom
