## EXISTING SITE CONDITIONS

### FLORA VISTA ELEMENTARY

Encinitas Union School District  
Facilities Plan Update

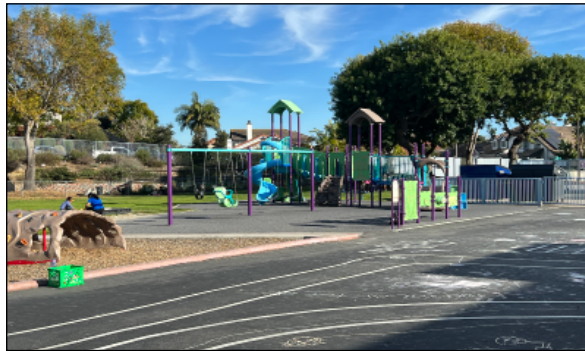
Hardcourts and Play Apparatus

- Hardcourts are in fair condition with some areas cracking. Grind, re-seal and re-stripe.

- Verify potential cross slope issues (>2%).
- Worn striping in some areas.
